RICS Building Survey...

Property address	Walsall
Client's name	Mr
Date of inspection	19 th October 2016

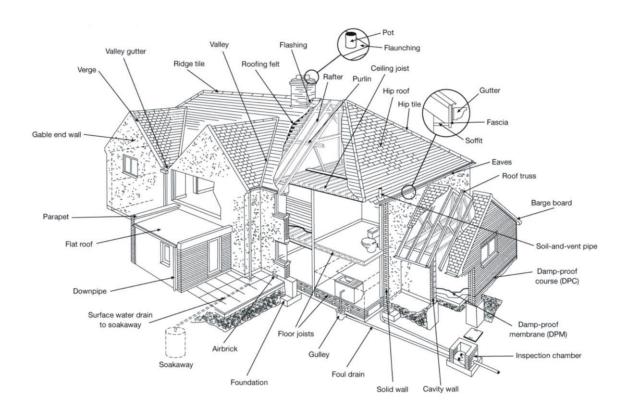
Typical house diagram

This diagram illustrates where you may find some of the building elements referred to in the report.
